The following article appears in the journal *JOM*, 53 (12) (2001), pp. 18.

An Initial Microstructural Analysis of A36 Steel from WTC Building 7

J.R. Barnett, R.R. Biederman, and R.D. Sisson, Jr.

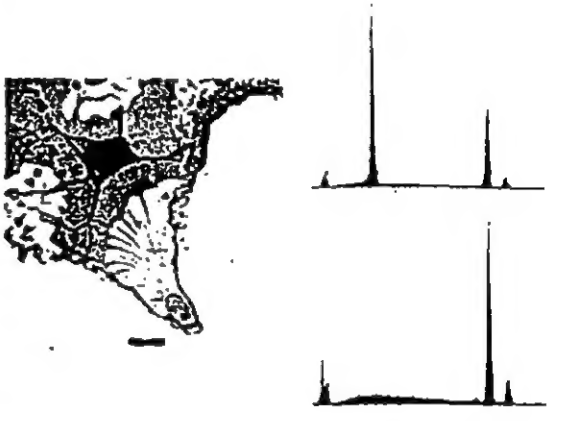
An EDX Analysis of eutectic region.

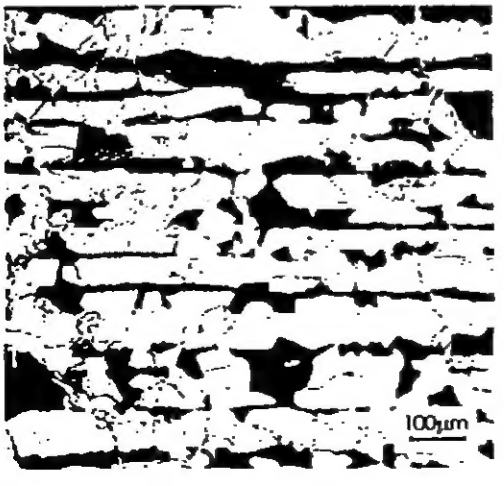
The microstructure of unaffected A36 steel: (a-left) white-ferrite, dark-pearlite and (b-right) pearlite region. Pearlite forms in bands due to manganese segregation and prior hot working.
